Manhole Inspection Summary

Manhole # S25II1001MH

Location Address: **4100 EVANS CHAPEL RD**

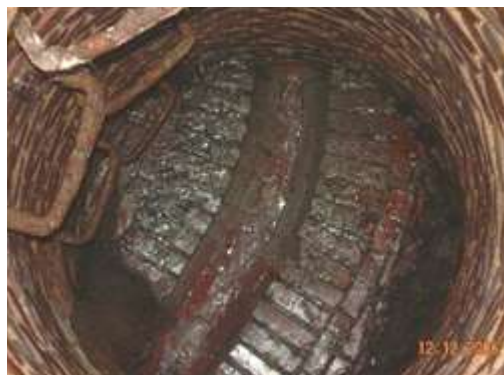
Top View

Corroded steps. Bench debris.

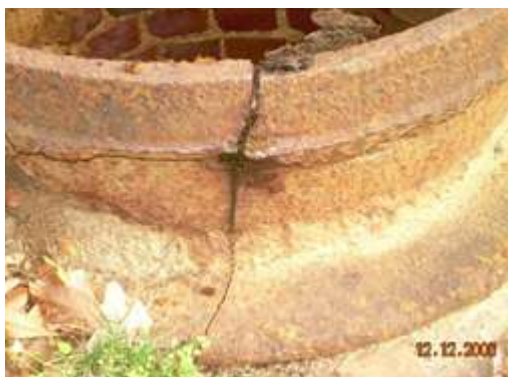
Defect

Cracked frame.

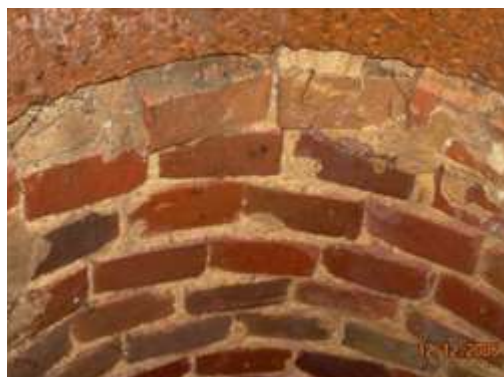
Defect

Adjustment deterioration and infiltration.

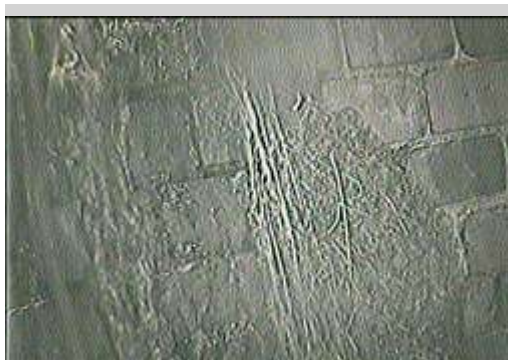
Defect

Barrel root intrusion and infiltration.

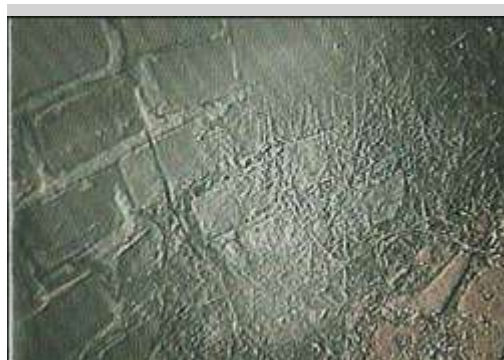
Defect

Barrel deterioration, root intrusion and infiltration.

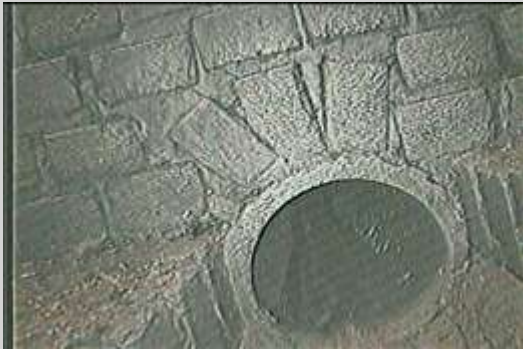
8 in. Circular Gravity Sewer Pipe Out @ 12 O'Clock

Infiltration: **None** Pipe Seal Cond: **Cracked**

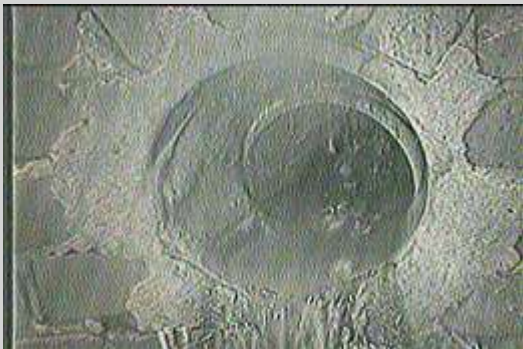
8 in. Circular Gravity Sewer Pipe In @ 7 O'Clock

Infiltration: **None** Pipe Seal Cond: **Cracked**

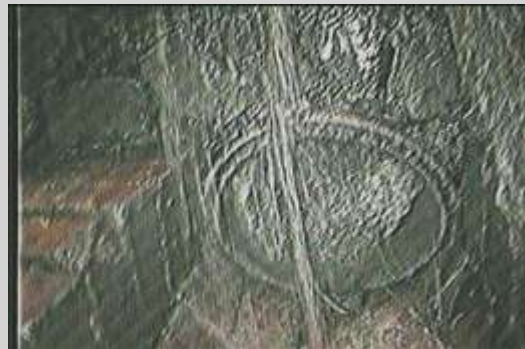
Drop In @ 7 O'Clock

Drop Condition: **Clogged**
